Re: Hazardous Waste Compliance Inspection
EPA ID number KSD007246846

RCRA Compliance Inspection Report

T/S/D Facilities Checklist

Facility Name Conservation Services--Hydrocarbon Recyclers, Inc

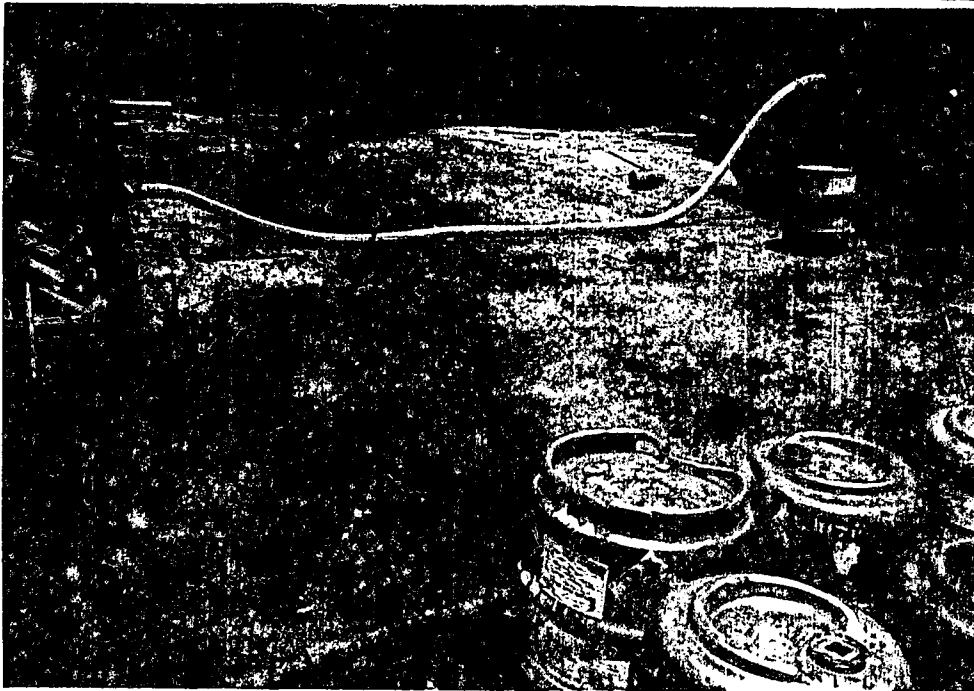
View of spillage
at acid unloading area -
Service Chemical. Small
drainage just beyond
fence

Because of the discoloration on the ground and other evidence of spillage at the acid unloading area, I strongly recommend a curbed, impermeable slab be installed. Any acid unloading or transfer should take place on this pad. It

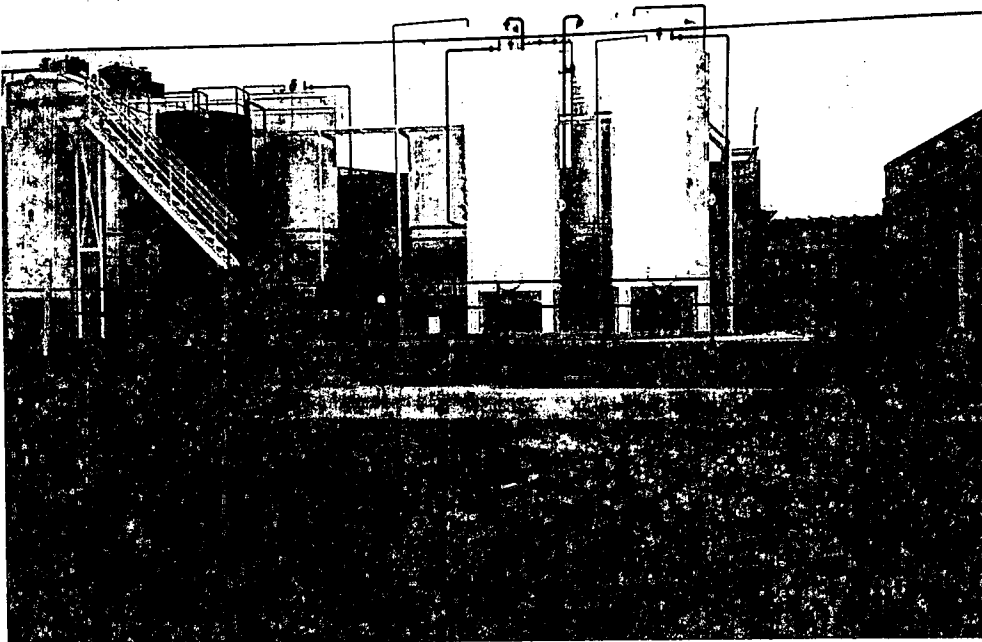
See photo. The brown tank and the two kiln fuel storage tanks are unpressurized. Only one of the tanks (#3) was in use at the time. They will probably start using the two kiln fuel tanks next month. The remaining tanks will be used within the next 2 months.

New hazardous waste

tanks

A new closure plan and cost estimates need to be drawn up for the new hazardous waste storage tanks.

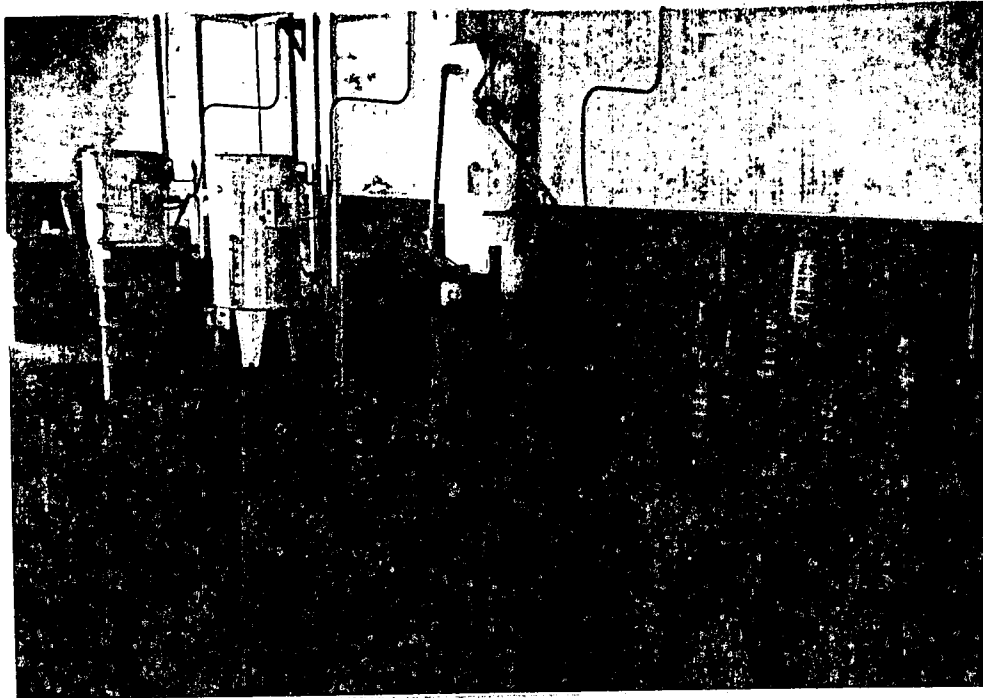
--The sparging room is in the south portion of building D. Several sparged perc cannisters were being stored in two piles against the wall. None of these were labeled. Dave said these were to be sent to USPCI. I told Dave these need to be kept in labeled containers, and to be handled as hazardous waste. He expressed surprise at this. He did not believe the paper filters remaining in the cannisters posed a problem. I referred him to Tom Gross's letter of March 4, 1988, where it was stipulated the paper filters had to be handled as hazardous.

A drum for collecting steam condensate was situated under the steam condensate line at each sparging unit. These drums were open. I told Dave they should have some kind of lid. One of the drums was empty, the other was 1/3 full of condensate.

There was also an open drum of sparged filters and carbon against the south wall. Another 4 drums of unsparged carbon were located in this area. They were properly labeled.

Inside sparging
room.

5. You must manage your containers in accordance with the requirements of 40 CFR 265 Subpart I, as referenced by K.A.R. 28-31-8. Containers of hazardous waste must be kept closed except when adding or withdrawing waste. During the inspection, I observed two open drums containing solvent waste at the blender/disperser area, one open drum of perc-contaminated condensate in the sparging room, and one open drum of perc-contaminated filters and carbon in the sparging room.

10. Since you are handling your dry cleaning cartridge paper as hazardous waste, you must store them in appropriate containers. During the time of inspection, these were just stacked against the wall in the sparging room.

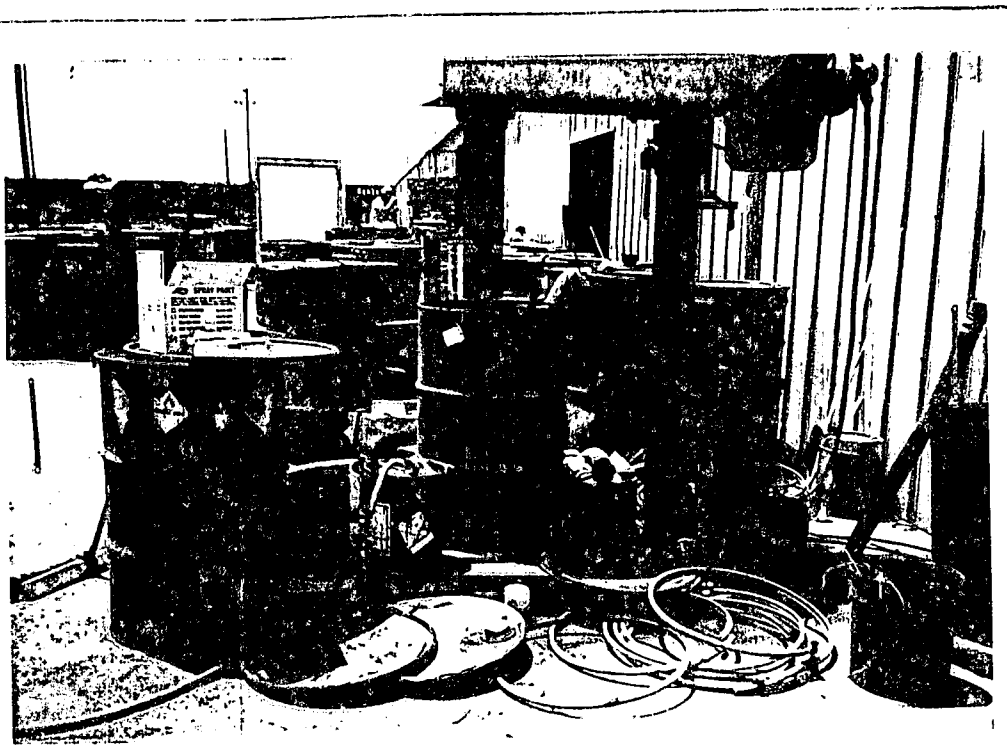
--The blender/disperser area was located just outside at the southeast corner. The blender was not being used because the storage tanks were not yet available for storage of the blended waste.

Two open drums of hazardous waste were in this immediate area. One was located just underneath the blender. A little further west in the staging area, was a bulged drum from the Iowa Army Ammunition Plant. Manifest #88031. I was told this was just received yesterday and they would be repackaging it into a salvage drum.

Blender/disperser area

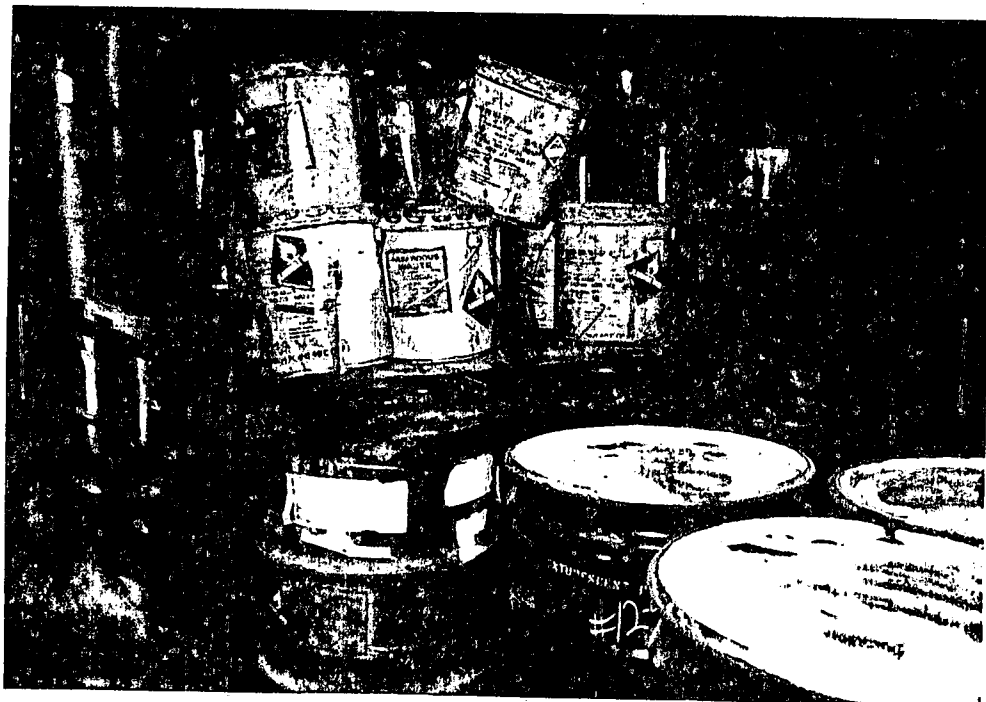
- At least 5 severely dented containers.
- One drum marked Koch Refinery, Corpus Christi, without hazardous waste label, date, or any other identification.

In Warehouse C.

Dented 5 gallon

containers of flammable

liquid on top pallet.

6. 40 CFR 265 Subpart I also requires containers of hazardous waste be in good condition and be marked with the words "Hazardous Waste". In warehouse C, I observed one severely dented 5 gallon container of waste flammable solvent; and, in the blender area, I noted a bulged container of hazardous waste from the Iowa Army Ammunition Plant. You also had a drum from Koch Refining in warehouse C that was not labeled.

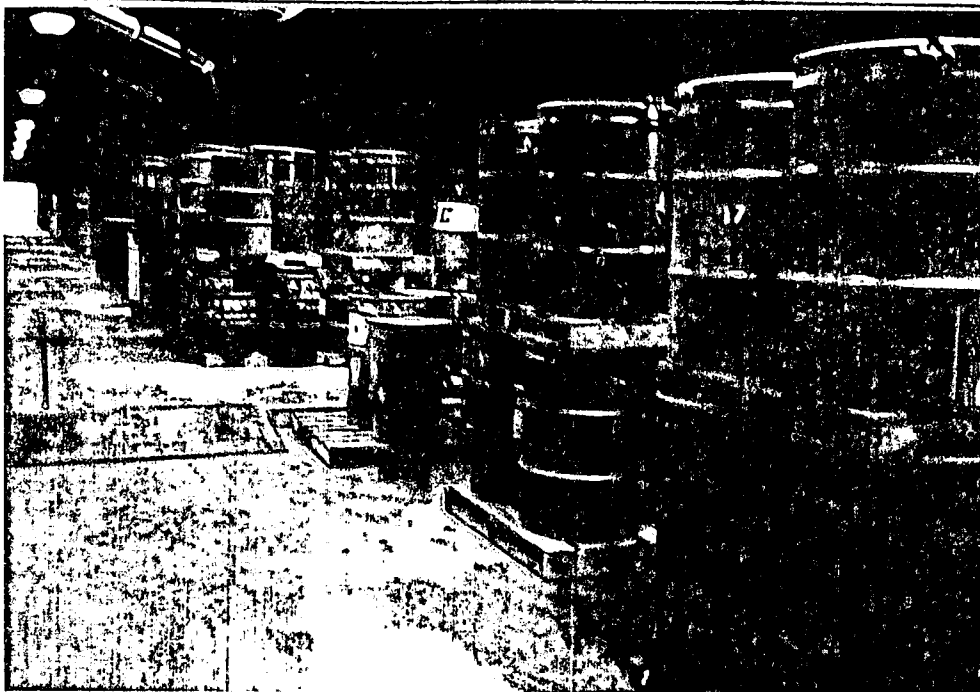
Some 1600 drums of hazardous waste were located in warehouse C. The drums were split up by 6" high curbing into separate areas (see photos). Acid corrosives were stored in a separate curbed area at the west end; alkaline corrosives were stored in a separate curbed area at the east end. Most of the flammables were stored towards the west end.

Warehouse C.
